Manhole Inspection Summary

Manhole # S33M1_021MH

Insp Date: **2/6/08 8:04 AM**

Location Address: **3000 Ascension St**

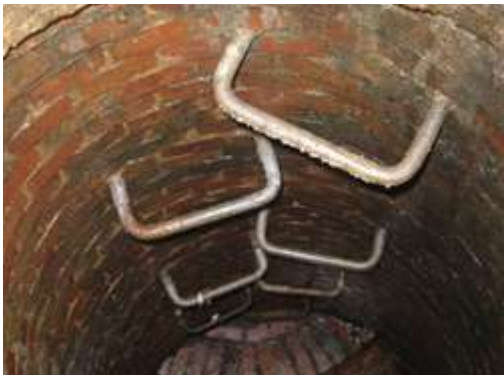
Steps Count: **9** Missing: **0** ☐ Corroded

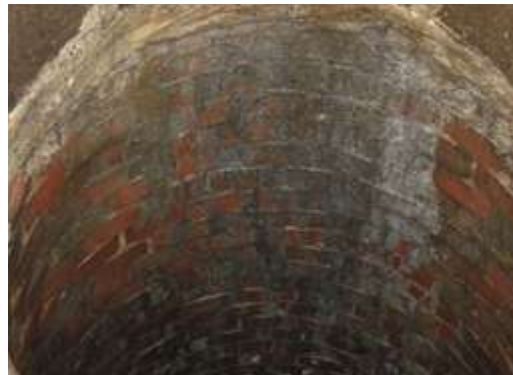
Defect 1

Infiltration: ☐ None ☐ Joint ☐ Cracks ☐ Mortar ☐ Roots ☒ Wall

Wall

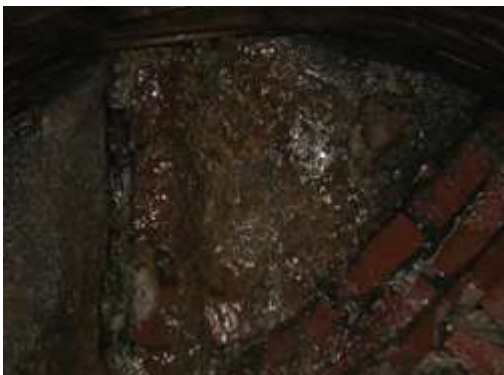
Defect 2

Bench

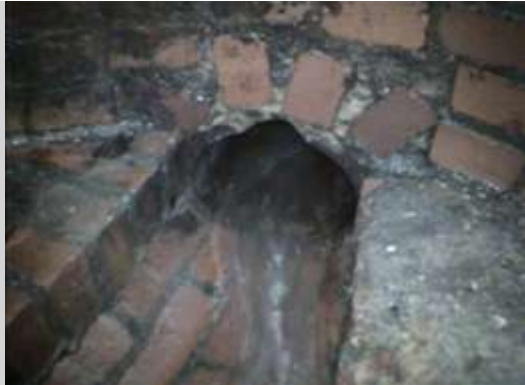
12 O'Clock Outflow

8 in. Circular Gravity Sewer
Pipe Out @ 12 O'Clock

Pipe Height: **9.6** (in.) Rod and Bar (Angled)
Pipe Material: **Clay** ☐ Pipe Lined
Invert Depth: **13.14** (ft.) Flow Characteristics: **Fast**
Deposits: ☒ None ☐ Mud ☐ Sludge ☐ Debris ☐ Grease
Silt Depth: (in.) Deposits Extent:
Infiltration: **None** Pipe Seal Cond: **Cracked**

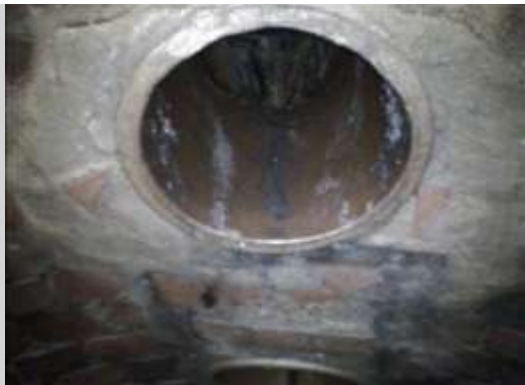
3 O'Clock Inflow

8 in. Circular Gravity Sewer
Pipe In @ 3 O'Clock

Pipe Height: **9.6** (in.) Rod and Bar (Angled)
Pipe Material: **Clay** ☐ Pipe Lined
Invert Depth: **10.63** (ft.) Flow Characteristics: **Fast**
Deposits: ☒ None ☐ Mud ☐ Sludge ☐ Debris ☐ Grease
Silt Depth: (in.) Deposits Extent:
Infiltration: **None** Pipe Seal Cond: **Sound**

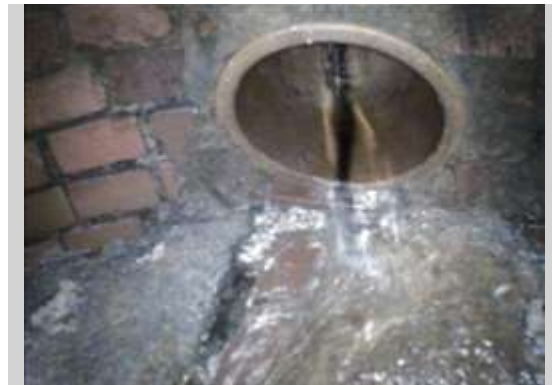
Drop In @ 3 O'Clock

Drop: **Outside** Rod and Bar
Angled: **Yes** Reading: **11.01** (ft.)
Inv Depth: **12.01** (ft.)
Drop Condition: **Open**

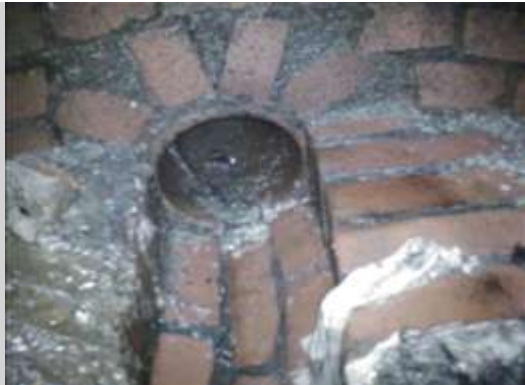
4 O'Clock Inflow

8 in. Circular Service Sewer

Pipe In @ 4 O'Clock

Pipe Seal Cond: **Sound**

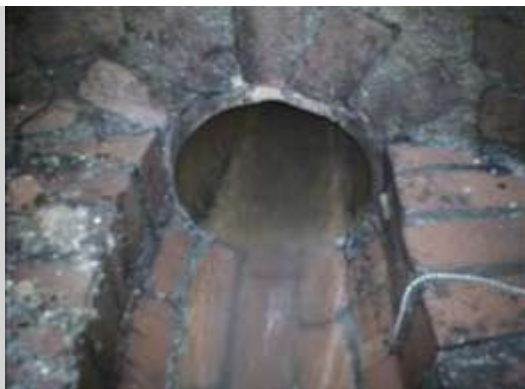
8 O'Clock Inflow

8 in. Circular Gravity Sewer

Pipe In @ 8 O'Clock

Pipe Seal Cond: **Sound**
